Rough visual cross-check of distance between target can of MET-01 and horn PH1-04 for NuMI 2014 Run

Jim Hylan

October 14, 2014

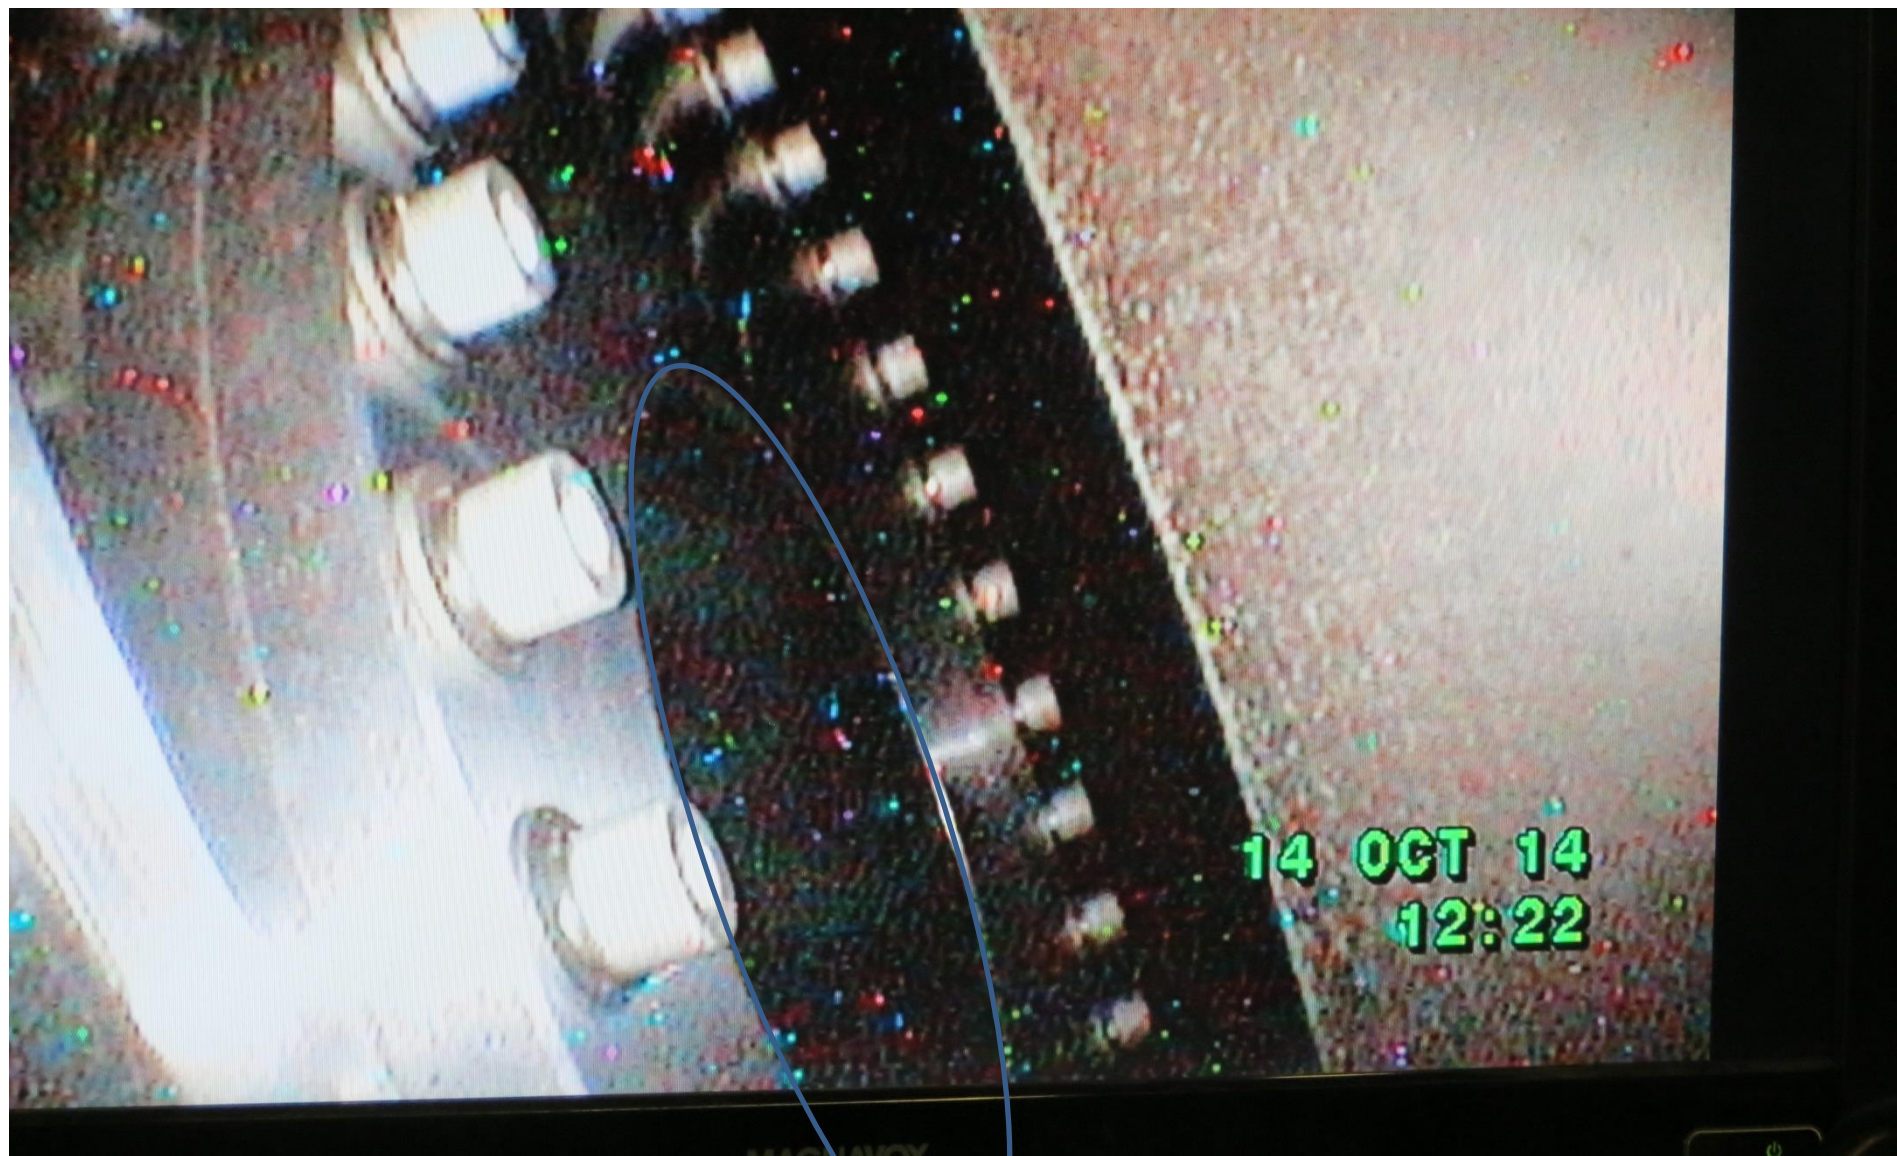
Photo IMG_2594 of MET-01 with ellipse around beryllium window

- The diameter of the downstream Beryllium window on the target can is 14 cm. In two pictures in this document, the diameter of that window is used to scale the distance between the target canister and the upstream end of the horn.

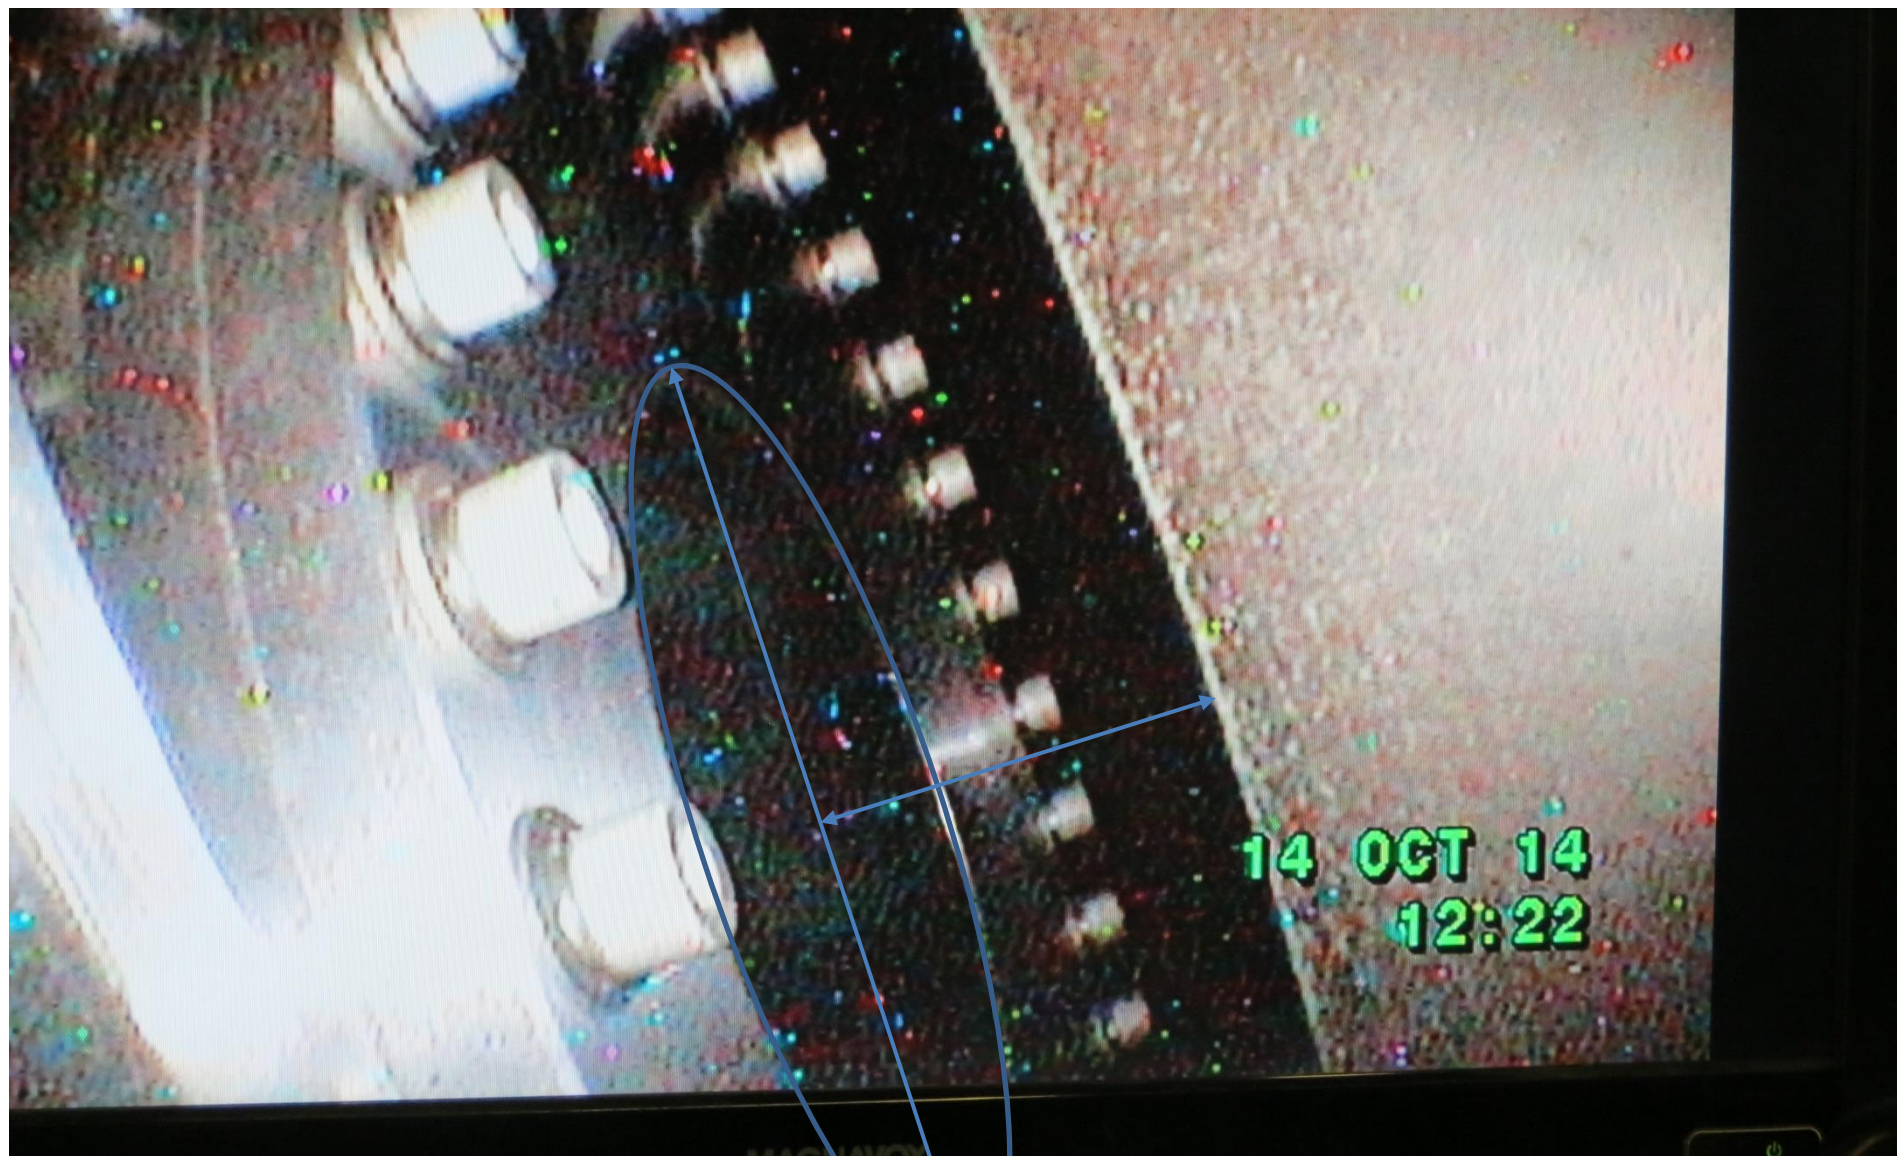
Photo IMG_2594 of MET-01 with ellipse around beryllium window and distance to horn 1

known diameter	ratio of features	derived distance	derived distance	
cm		cm	inch	
14	def. 100%			diameter of Be window
	43%	6.00	2.36	center of ellipse to horn, 1st photo
14	def. 100%			diameter of Be window
	41%	5.68	2.23	center of ellipse to horn, 2nd photo

Given the technique and that the lighting did not well display the entire window on a single picture, would not be surprised by error ~ 10% or 15%.

But there is certainly visual agreement at that level with expected gap

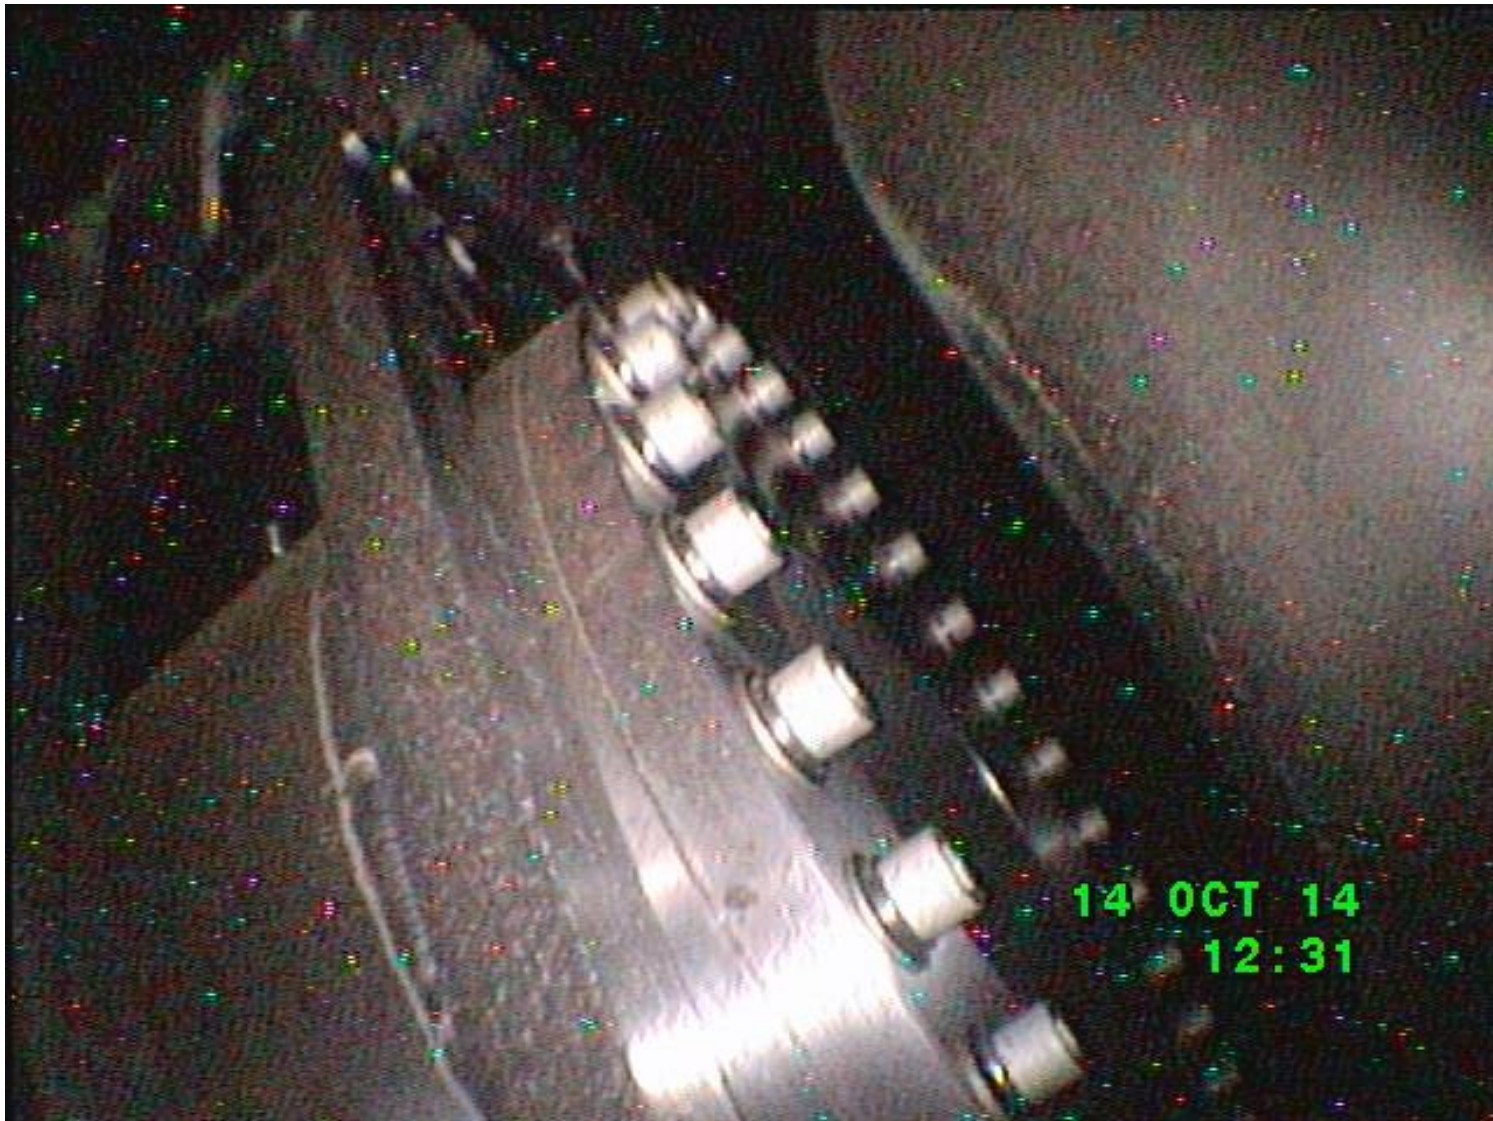
Photo 141014AE of MET-01 with ellipse around beryllium window

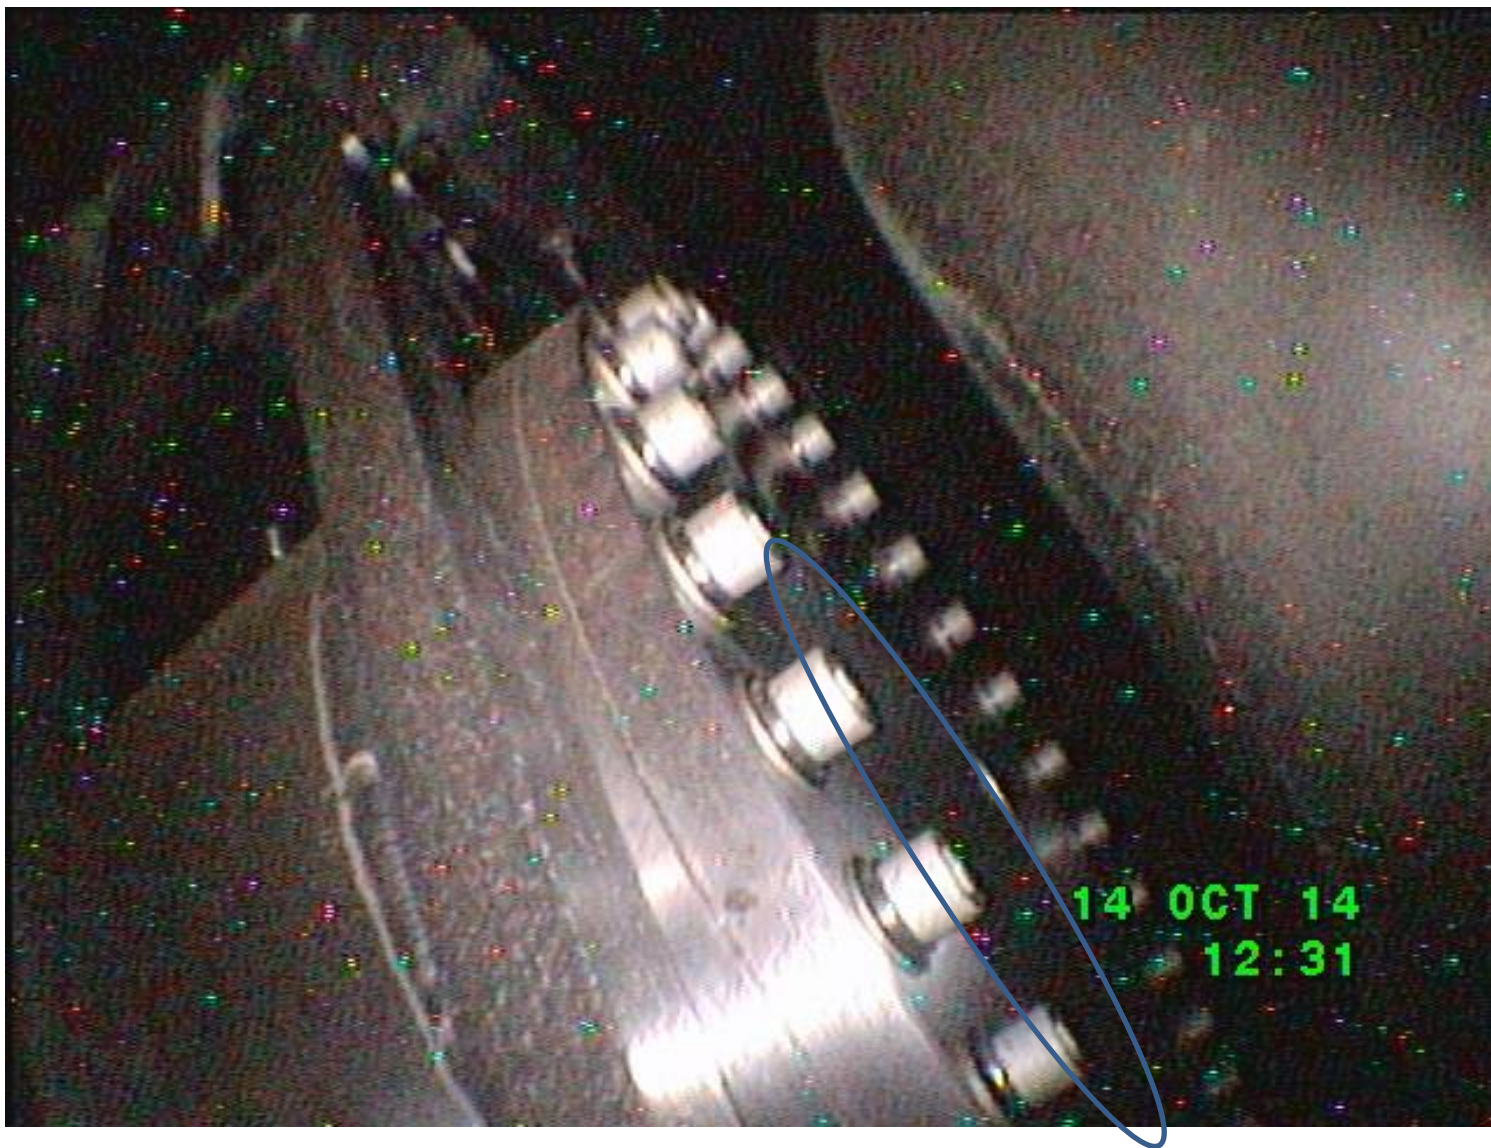
Photo 141014AE of MET-01 with ellipse around beryllium window and distance to horn 1

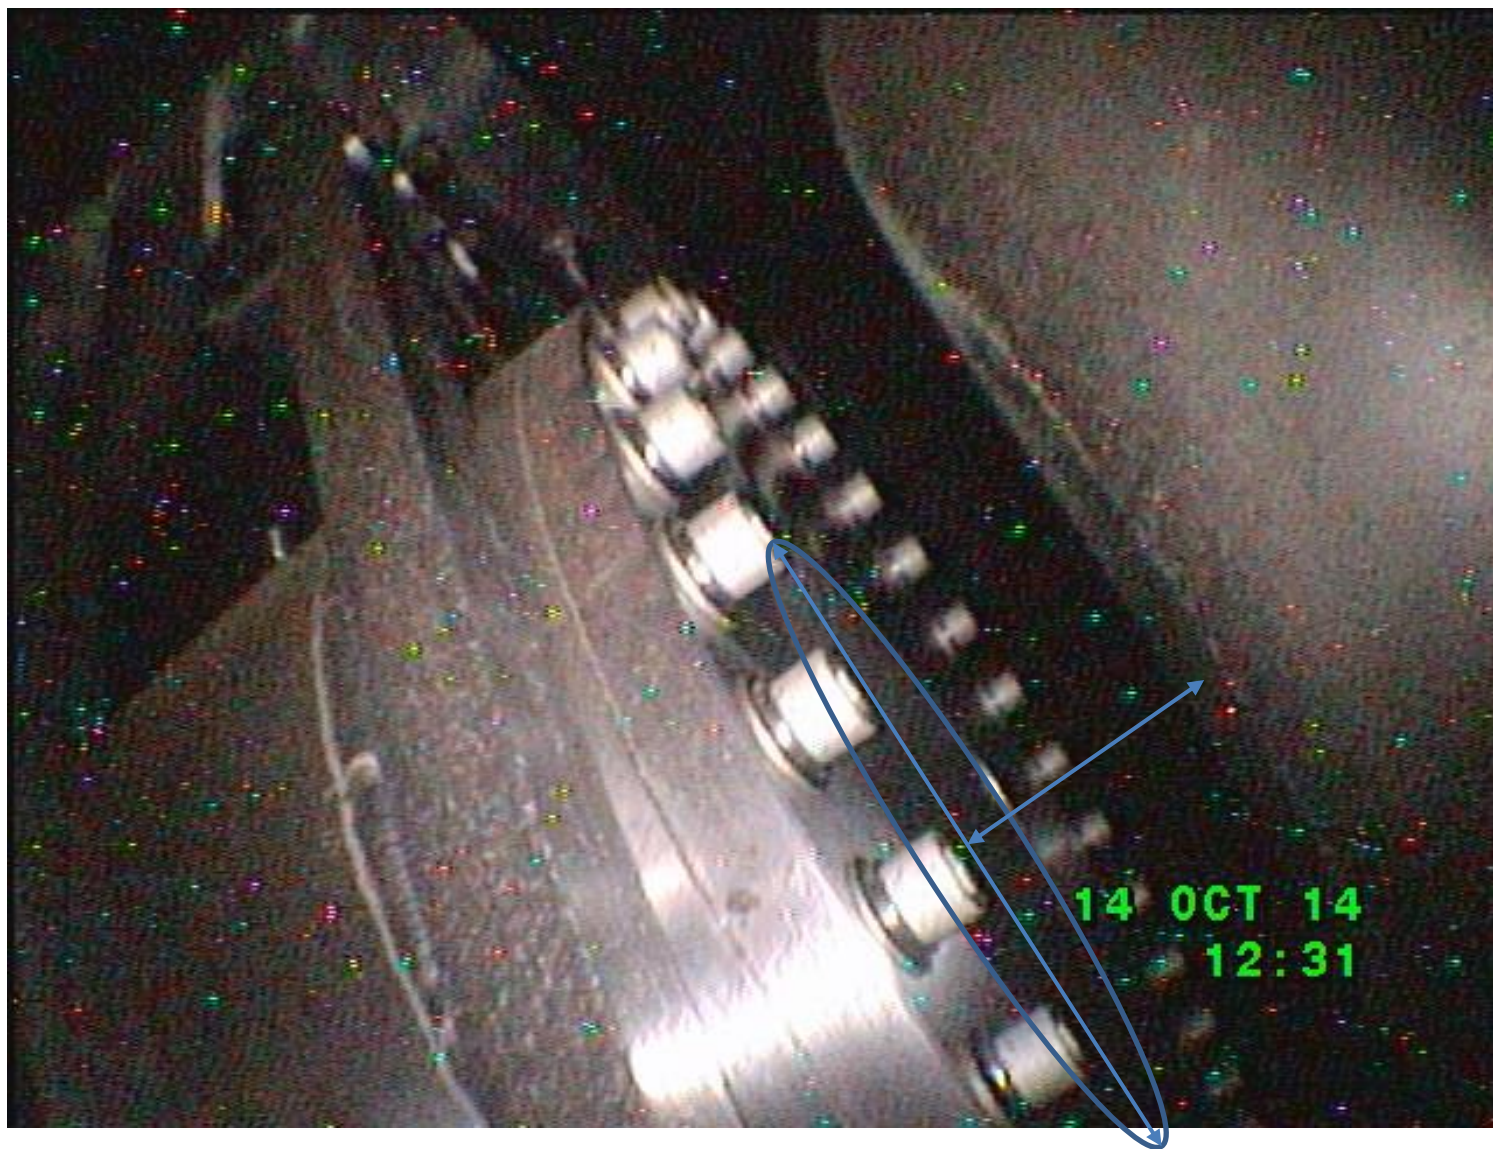
From integration plan drawing ME-433995

cm	inch	
	2.566	integration plan distance window to horn
20.13		integration plan fin end to MCZERO
19.43		installed survey fin end to MCZERO
-0.7	-0.28	delta installed versus planned
	2.29	expected clearance
